The Diagnosis of Maritime Structures, a Management Support Tool: Case of the Sèmè-Podji Wharf in the Republic of Benin

Babilas Hountondji*, Lambert K. Ayitchéhou, François de Paule Codo, Martin P. Aina

How to cite this paper: Hountondji, B., Ayitchéhou, L.K., Codo, F.P. and Aina, M.P. (2025) The Diagnosis of Maritime Structures, a Management Support Tool: Case of the Sèmè-Podji Wharf in the Republic of Benin. *Open Journal of Marine Science*, 15, 1-12.

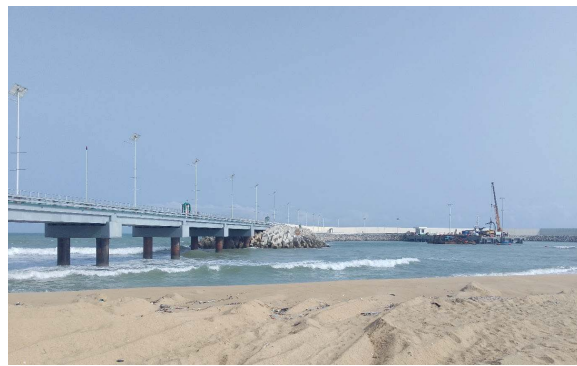
Figure 1. Sèmè-Podji wharf.

The commune of Sèmè-Podji and its coastline historically constituted a rich natural environment free from major disturbances. Unfortunately, for several years, after the construction of the wharf (**Figure 1**) by the Chinese company WAPCO as part of the project to export oil from Niger through Benin to other countries, local users have been confronted with a phenomenon of fattening west and erosion to the east of the structure on the coast.

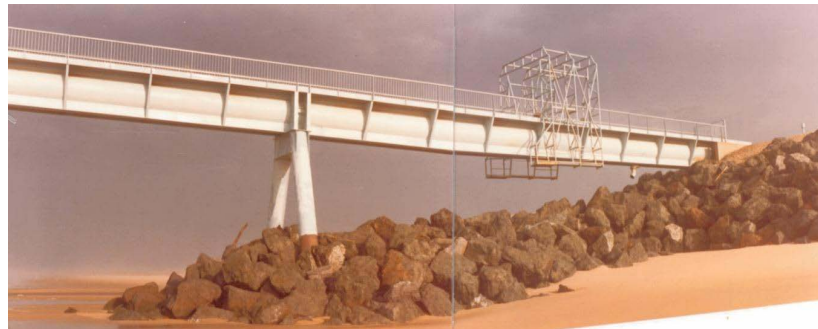
Figure 2. Protection of the piers of the Salie Wharf [1].

So today, on the coastline of the municipalities concerned, the situation is such that it could in the short term endanger coastal facilities (beach plans, homes, etc.) and degrade the quality of seaside reception. And therefore, the Syndicate Intercommunal du Bassin d'Arcachon (SIBA) anticipated the sedimentary modifications to the right of the structure in order to plan sustainably and in a relevant manner specific developments on the network. Indeed, if sedimentation is observed in the area of the structure, very strong erosions may have taken place in the past at its roots, leading to work to reinforce the piers of the structure.

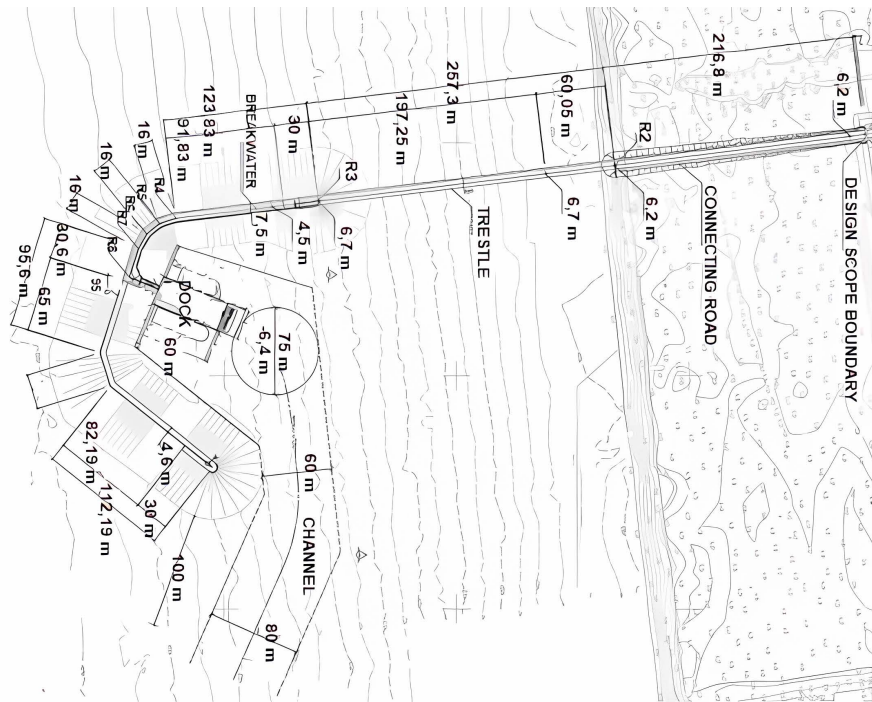
Figure 3. Plan view of the Sèmè-Podji wharf (Source: WAPCO, 2023).

Built between 2019 and 2022 by the Chinese company WAPCO, the Sèmè-Podji wharf built as part of the Niger – Benin pipeline project (export of oil from Niger to other countries) has at its end (sea side) a quay allowing the docking of the three launches available to the company, to carry out operations at sea. The structure with a total length of 666.96 meters is made up of:

- a maritime bridge with a length of 257.3 meters and a width of 25 meters comprising three rows of reinforced concrete piles with a diameter of 1.20 meters, each row being crowned by a reinforced concrete beam of prefabricated elements keyed by concreting on the piles;
- a protective dike with a length of 409.66 meters and a width of 18 meters;
- a quay with a length of 60 meters and a width of 25 meters, comprising three

rows of reinforced concrete piles with a diameter of 1.20 meters, each row being crowned by a reinforced concrete beam of keyed prefabricated elements by concreting on the piles. **Figure 3** and **Figure 4** respectively present the plan view of the wharf and the cross section of the maritime bridge of the wharf of the Sèmè-Podji pipeline which is the subject of our study.

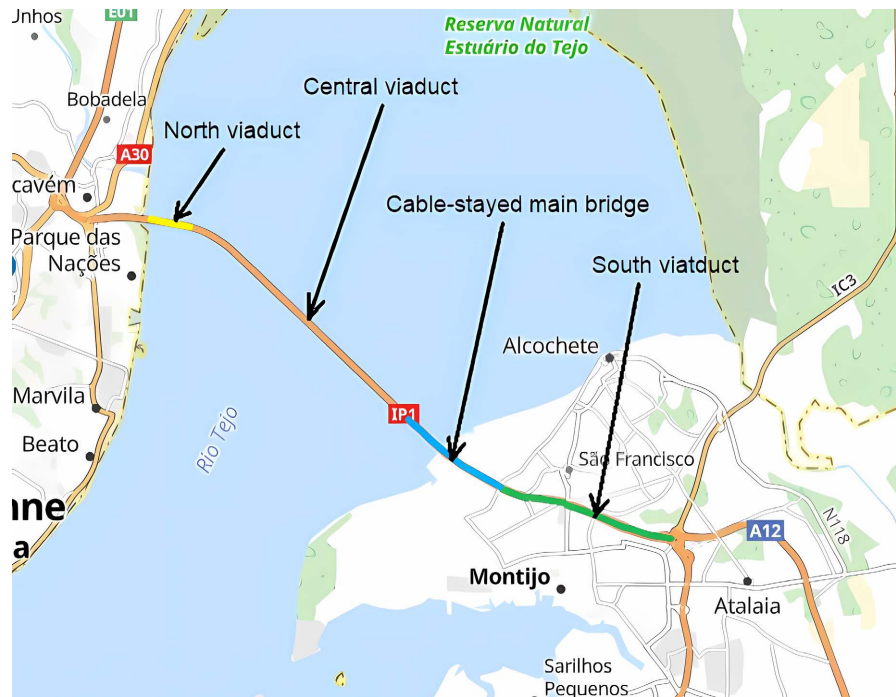
Figure 5. Schematic plan view of project [3].

- a North viaduct, 488 m long (11 spans with an average of 45 m). The piles are built on piles 1 m in diameter.
- an Expo viaduct 672 m long (12 spans from 45 m to 62 m). The piles are built on piles 1.70 m in diameter.
- a main cable-stayed bridge 820 m long, with a central span of 420 m above the main navigable channel. The deck is held transversely by three double piers on each side of the main span. The foundations are made of 2.20 m piles.
- a central viaduct 6531 m long, made up of 09 viaducts of 09 spans of approximately 80 m. Each navigable channel has special spans. The piers are built on piles with a diameter of 1.70 m for standard spans, and 2.20 m for navigation spans.
- a South viaduct, 3825 m long, has a section similar to that of the North viaduct. The piles are built on piles of 1.80 m or 2 m in diameter.

Figure 5 and **Figure 6** respectively present the plan views of the project and the general view of said project identified as a control project within the framework of this study.

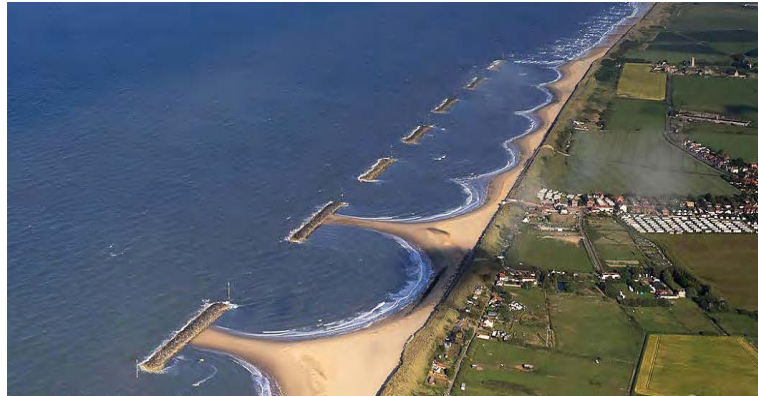
Figure 10. Breakwater battery: long-term solution [4].

The breakwater is a tool for managing the longitudinal coastline to protect the

coast from transverse swells (**Figure 10**). Placed on the foreshore or further off-shore, the breakwater aims to break swells perpendicular to the coast in order to attenuate their force.

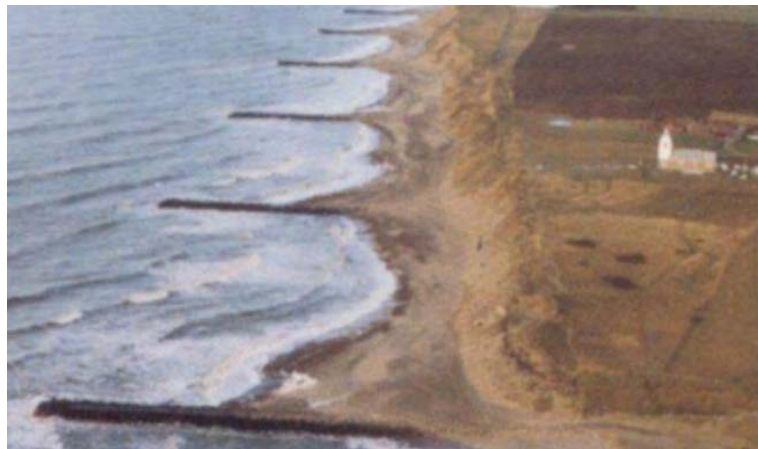
Figure 11. Groyne battery: long term solution [4].

Groynes are coastal structures designed to retain sediment by preventing it from moving along the shoreline and to help maintain wide beaches by minimizing or slowing erosion [5]. It is a transversal shoreline management tool (**Figure**

11) relying on currents to modify the coastline. Placed on the foreshore, the groyne aims to break the dynamics of coastal drift. Cross-shore currents are not affected by this type of structure.
