Environmental Impact of Kakhovka Dam Breach and Chernobyl Nuclear Power Plant Explosion on Dnieper River Landscape

Kenneth Ray Olson

How to cite this paper: Olson, K.R. (2024) Environmental Impact of Kakhovka Dam Breach and Chernobyl Nuclear Power Plant Explosion on Dnieper River Landscape. *Open Journal of Soil Science*, 14, 353-387. <https://doi.org/10.4236/ojss.2024.146020>

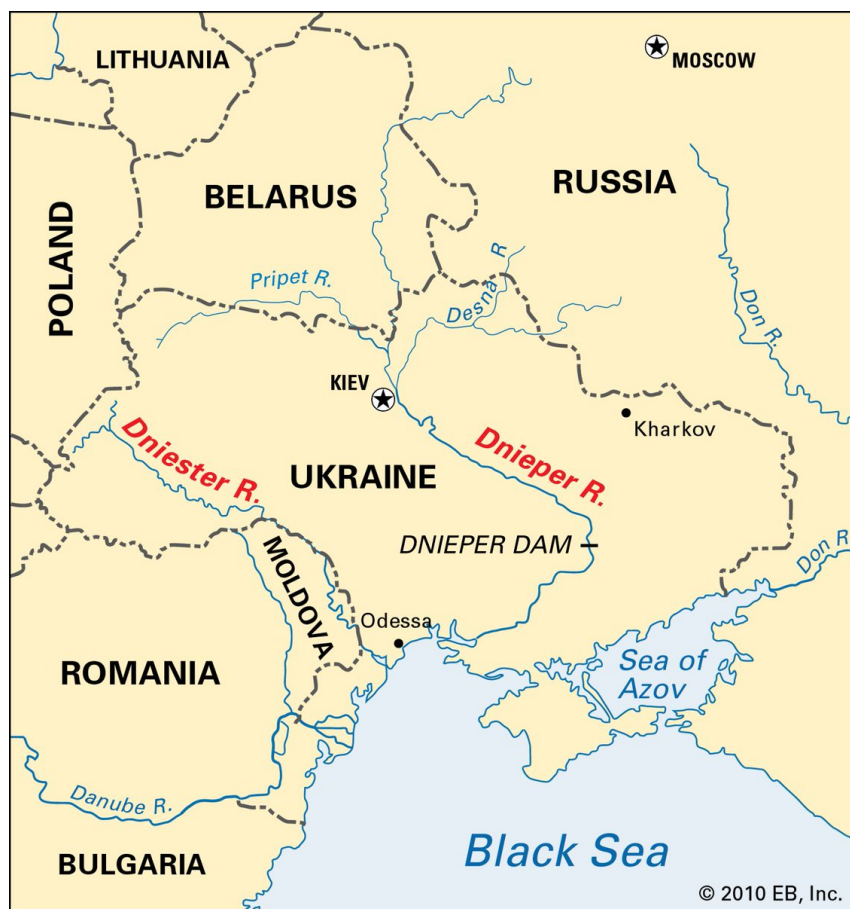
Figure 1. Map showing the location of the Dnieper and Dniester Rivers. Photo Credit: mappingmemories.ca.

The Dnieper River headwaters are at a 220 m elevation in Russia's Valdai Hills and the river flows south to the Black Sea (**Figure 1**). The 2180 km river and watershed are in western Russia, Belarus, and Ukraine. The Dnieper River has three sections, the lower portion is between Zaporizhzhya and the delta (**Figure 2**) at the Black Sea [1]. The middle portion is the area between Kiev and the Ukrainian city of Zaporizhzhya and the upper portion extends from Kiev (**Figure 3**) to the headwaters in western Russia. The Dnieper River provides a waterway in which to transport goods to and from various European nations. In addition, the dams on the river provide hydropower [2]. Approximately, 480 km of the waterways are in Russia, 690 km in Belarus, and 1190 km within Ukraine. Only the Danube, Ural and Volga rivers in Europe are longer than the Dnieper River.

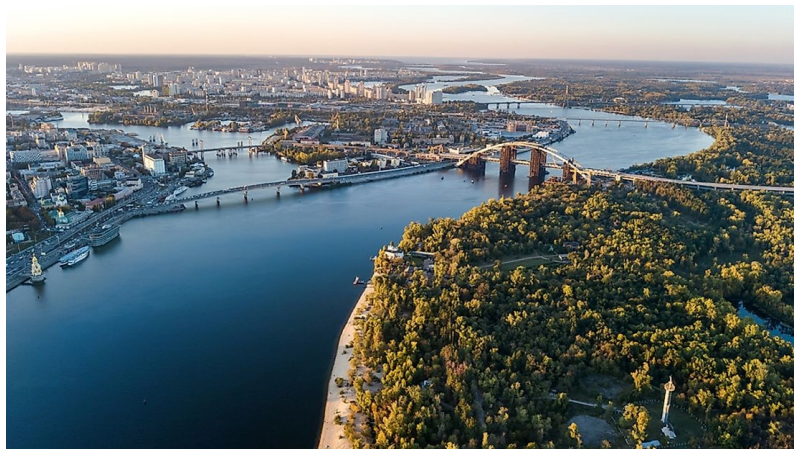
Figure 4. Four motor bridges and one railroad bridge over the Dnieper River in Kiev, Ukraine. Photo Credit: Encyclopedia Britannica, Cavan iStock/Getty images.

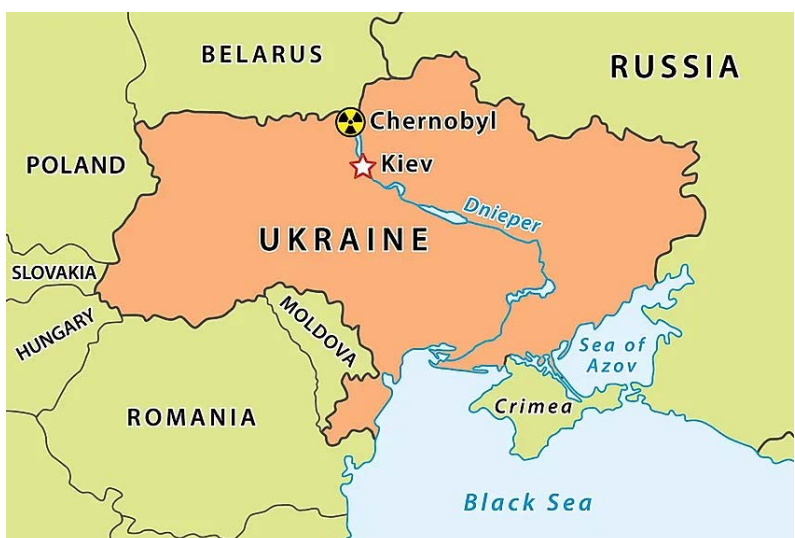
Figure 5. Ukraine map showing the location of the Dnieper River and Chernobyl. Photo Credit: In the Public Domain.

After the Chernobyl explosion in Ukraine a radiation cloud (**Figure 18**) drifted 800 km to the northeast and over Soviet Union (**Figure 5**). When it rained near the city of Tula, south of Moscow, the ^{137}Cs isotope levels in the soil were increased by 10-fold [18] [19]. Since the mid-20th century, the presence of the artificial ^{137}Cs

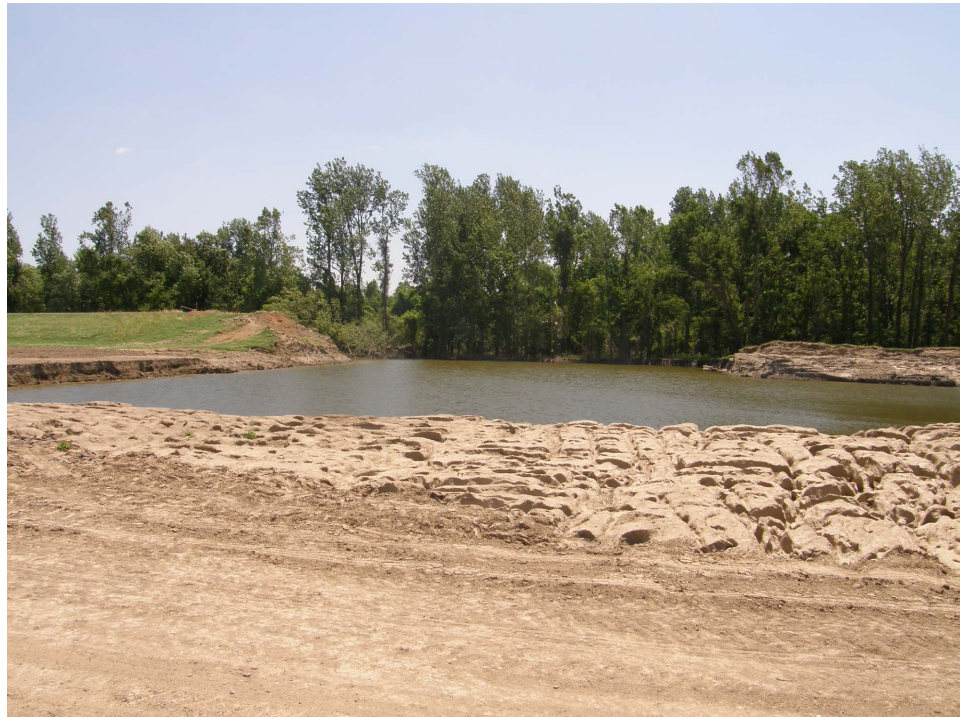
Figure 8. The Birds Point levee breach created a crater lake that extended many meters through the levee.

Olson and Morton [8] found “*The induced breach at Birds Point, Missouri, the first explosion site (Figure 8) and flooding of the New Madrid Floodway and basin on May 2, 2011, resulted in no loss of life thanks in part to the US National Guard sweep of the area to make sure the people living and working in the Floodway were evacuated [8]. The force and impact of the floodwater on the 470 km² of the Floodway may have been greater than projected in the 1983 Corps of Engineers operational plan. The Floodway was subjected to rapidly moving floodwaters which were initially 1.2 m deeper than would have been released if the fuse plug was blown when the Cairo levee was at 17.7 m. There was severe damage to most of the 200 or more buildings, including homes, which were exposed to 0.9 to 1.8 m of flowing water and then partially submerged in 1.8 to 3 m of floodwater. Water pressure caused loss of the lower one-third to one-half of entire walls, damaged most wooden floors, and in some cases, destroyed structures (Figure 10).*”

The deliberate breaching of the Birds Point levees (**Figure 8**) (**Figure 11**) in the New Madrid Floodway downriver from Cairo in May 2011 was a planned strategy of the United States Corps of Engineers (USACE) to prevent levee failures and to reduce water pressure where harm to human life might occur. The induced breach and the flooding of 53,824 ha of Missouri farmland resulted in the loss of 2011 crops and damage to future soil productivity. The strong current and sweep of water through the Birds Point, Missouri breach damaged irrigation equipment, farms, and home buildings and created deep gullies, and displaced tons of soil.

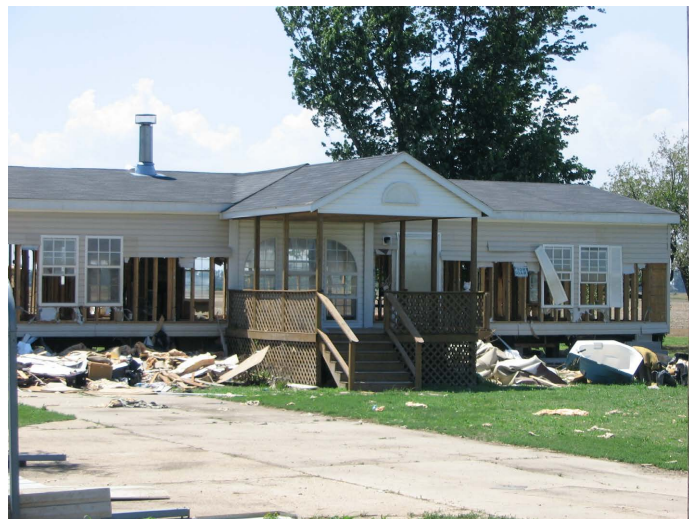
Figure 10. One of the 80 homes in the floodway was damaged by 2 to 3 m of floodwater in 2011.

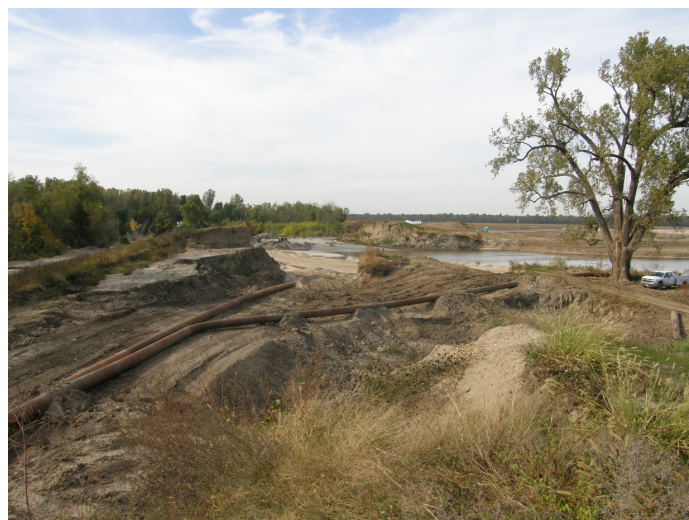
Figure 11. A crater lake was formed at the Big Oak Tree frontline levee when the fuse plug was blown and floodwaters rushed into the floodway.

“*On May 3, 2011, the lower plug levee was blown up near New Madrid, Missouri, the second explosion site (Figure 11) to begin the return of the stored floodwater back into the Mississippi River. However, the Mississippi River was still too high to allow a quick drop in the floodwater in the New Madrid Floodway. The USACE planned to blow up the frontline levee in two places using 150 tons of TNT near Big Oak Tree State Park in Missouri, the third explosion site (Figure 11), on May 4, 2011, but weather and shortage of TNT delayed the third*

frontline levee near Big Oak Tree State Park was opened with trinitrotoluene (TNT) on May 5, 2011 (**Figure 11**). There was severe damage to most of the 200 building structures, including 75 homes, which were exposed to flowing floodwater. These buildings were damaged when they were partially submerged in 1.8 to 3 m of temporarily stored floodwater” [11] [13].

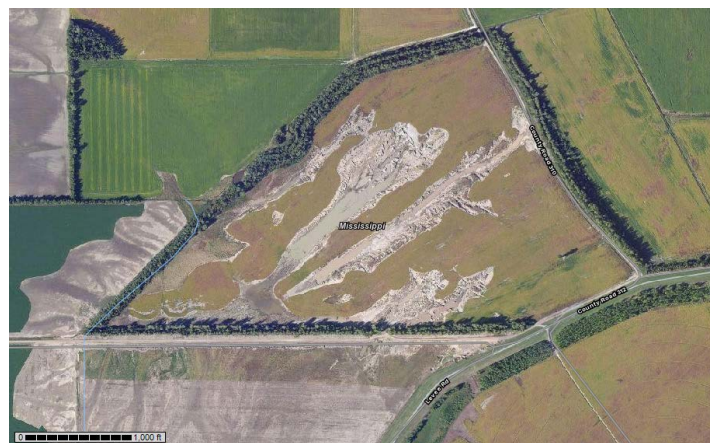
Figure 12. May of 2011 aerial view of O’Bryan ridge gully fields.

to parts of the area. Other areas took another year for the drainage to be restored. However, the unanticipated fields with deep large gullies were difficult to repair (Figure 12). It was rather difficult to regrade and reshape these gullies in isolated cultivated fields on ridges or second-bottom soils. These fields of gullies caused the permanent loss of agricultural land. Even after reclamation of the fields of gullies, these soils had lower productivity. In many cases, the alluvial parent material became the land surface with less soil aggregation, less soil organic carbon, and more slope. The reclamation effort restored some of the permanently lost cropland in sand delta and crater lakes and/or created wildlife habitat and additional wetlands adjacent to the patched levees.

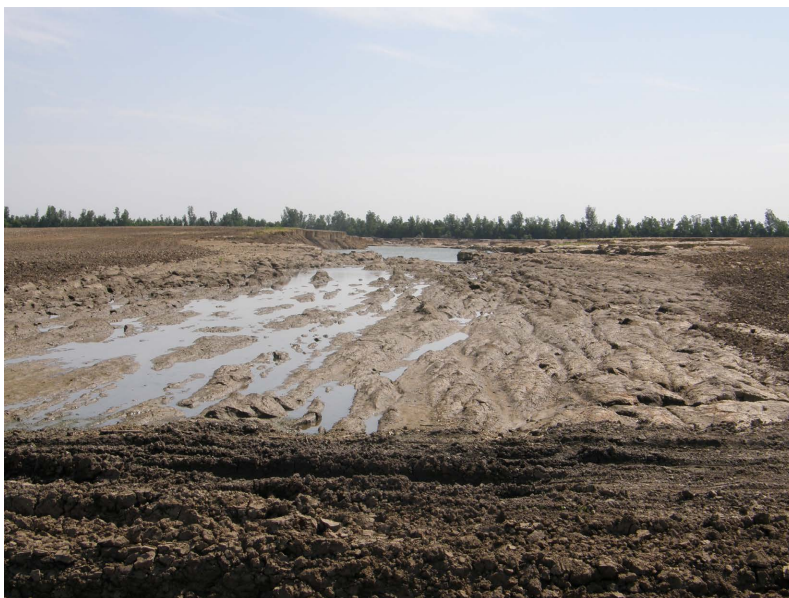
Figure 14. Land scoring of the bottomland located below the O'Bryan Ridge gully fields.

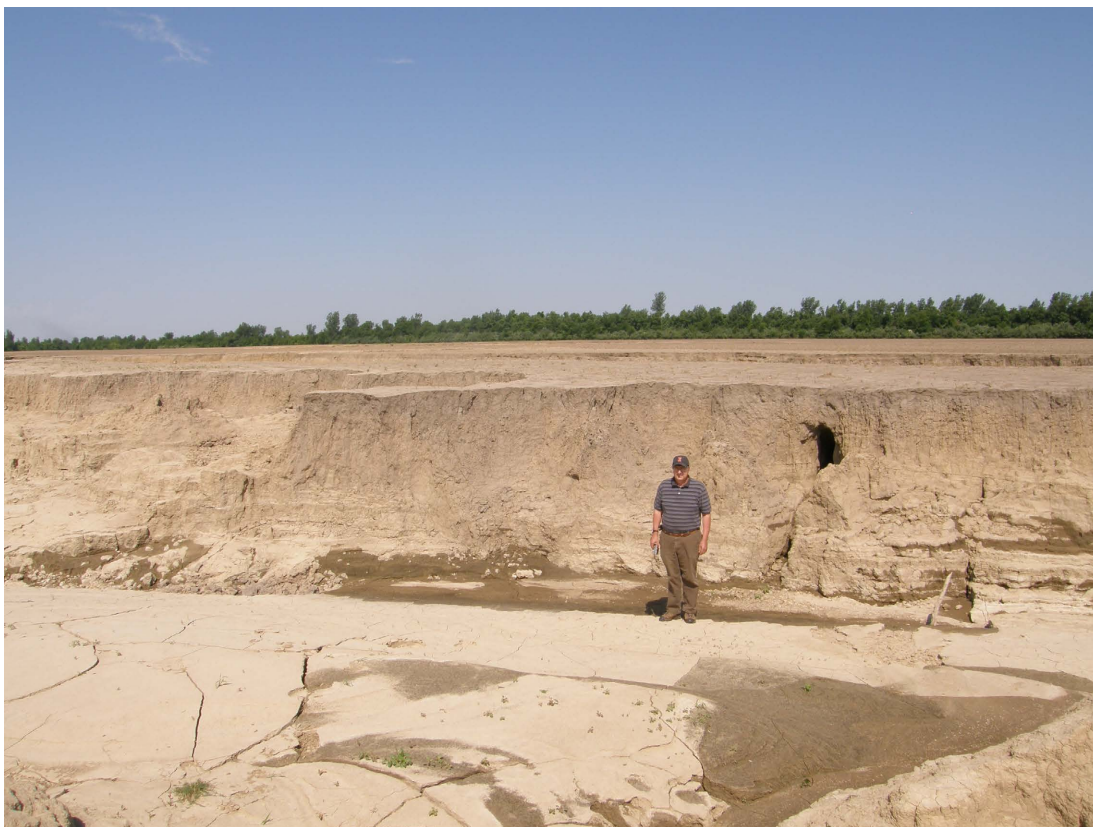
Figure 15. Gullies and channels were created from May 16, 2011. The main channel and attached gullies were 4 m deep and removed cropland from production.

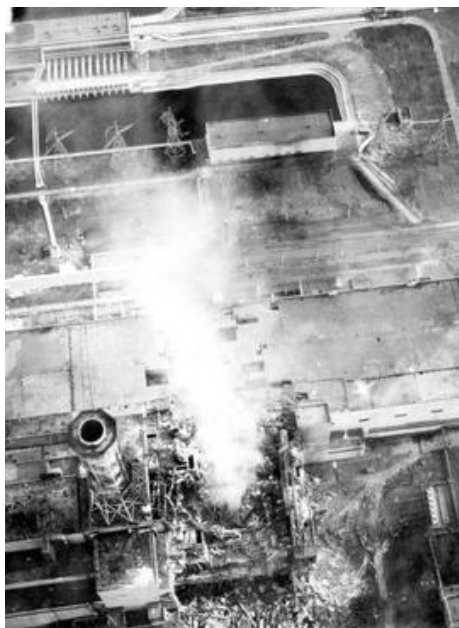
Figure 18. Smoke from Chernobyl number 4 reactor burning. Aerial view. Photo Credit: Wikipedia.

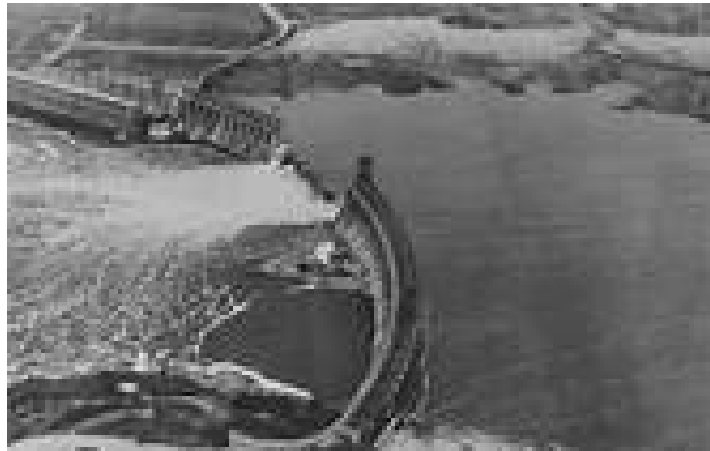
Figure 19. Destroyed Dnieper River dam. New York Times. Photo Credit: Nicole Tung.

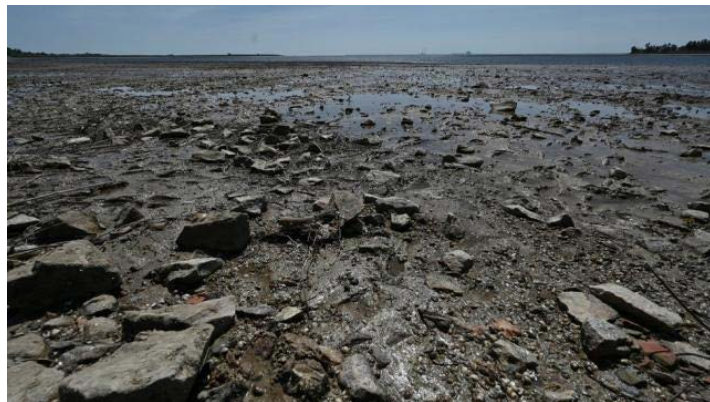
Figure 20. Dnieper reservoir bed after water level dropped. Photo Credit: AP.

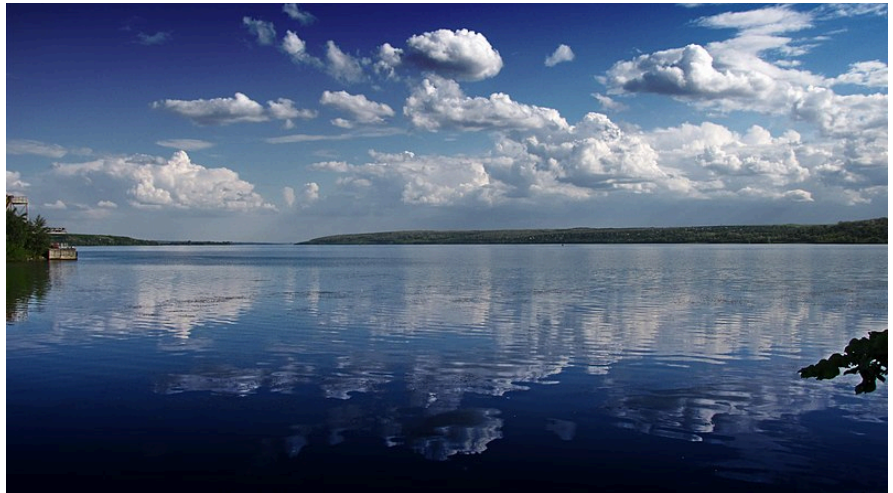
Figure 23. Dnieper Reservoir. Photo Credit: Encyclopedia Britannica.

The Dnieper Rapids were part of the trade route used by the Greeks and Varangians. The route was probably most likely established in the late eighth and early ninth centuries and gained significant importance in the tenth and eleventh centuries. On the Dnieper the Varangians had to portage their ships round seven rapids. Along this middle flow of the Dnieper, there were nine major rapids and about 30 to 40 smaller rapids, and approximately 60 islands and islets. After the Dnieper hydroelectric station was built in 1932, they were inundated by Dnieper Reservoir (Figure 22) (Figure 23) (Figure 24).

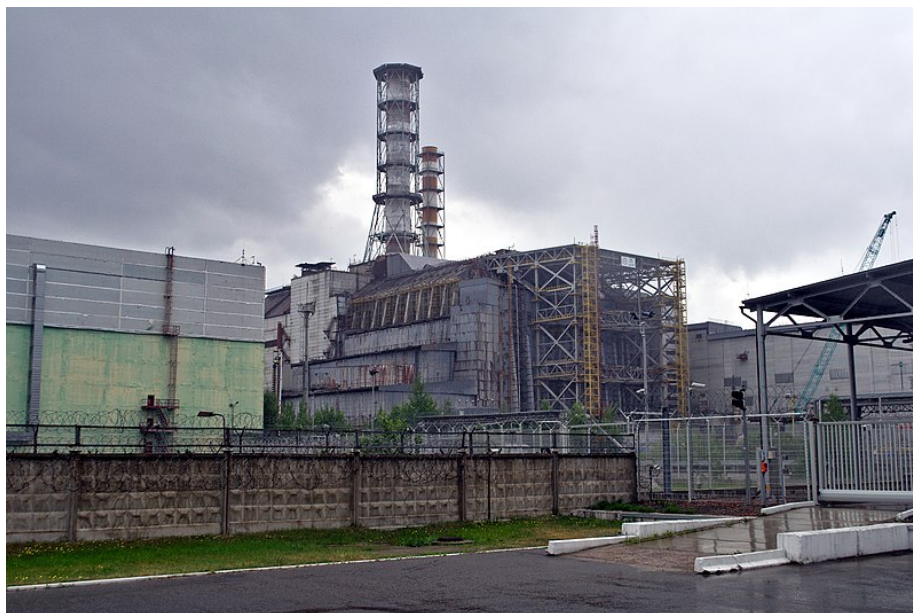
Figure 25. Chernobyl nuclear plant. Photo Credit: Pawel Szubert.

“*On April 25, 1986, routine maintenance was scheduled at V.I. Lenin Nuclear Power Station’s fourth reactor (Figure 25), and workers planned to use the downtime to test whether the reactor could still be cooled if the plant lost power. During the test, however, workers violated safety protocols and power surged inside the plant. Despite attempts to shut down the reactor entirely, another power surge caused a chain reaction of explosions inside. Finally, the nuclear core itself was exposed, spewing radioactive material into the atmosphere. Firefighters attempted to put out a series of blazes at the plant, and eventually, helicopters dumped sand and other materials to squelch the fires and contain the contamination. Despite the death of two people in the explosions, the hospitalization of workers and firefighters, and the danger from fallout and fire, no one in the surrounding areas—including the nearby city of Pripjat, which was built in the 1970s to house workers at the plant—was not evacuated until about 36 hours after the disaster began*” [41].
